RE: Wetlands and Waterways Delineation

WM PROJ. DESCR.: Halfway Boulevard Extended

TYPE I TECHNICAL NOISE ANALYSIS HALFWAY BOULEVARD EXTENDED

Washington County, Maryland

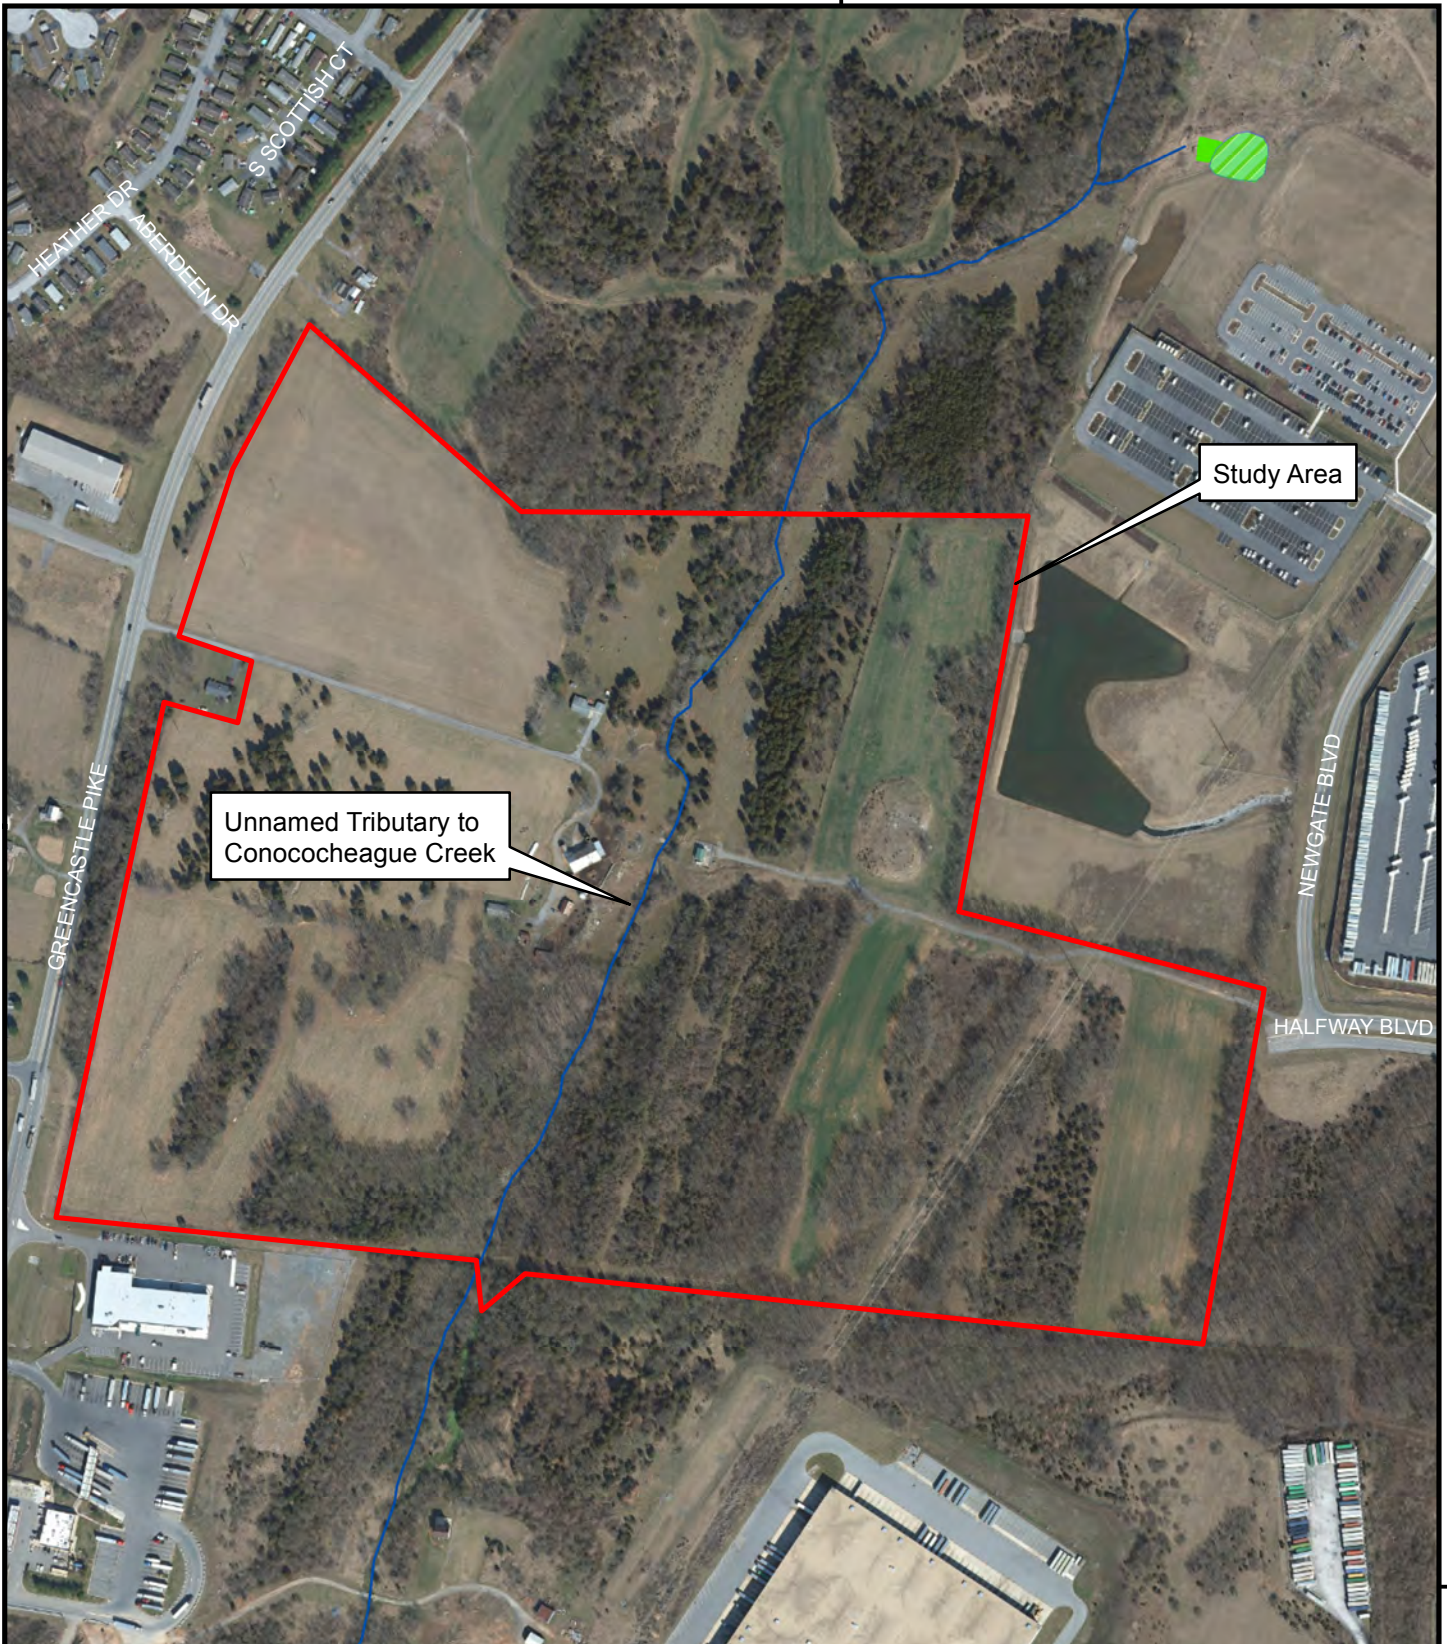
DNR/NWI WETLANDS MAP

The study area falls within the Conococheague watershed (MDE 8-digit 02140504). The study area is within a FEMA mapped 100-year floodplain. DNR wetland mapping identifies one stream within the project area (R3UBH). Web Soil Survey (NRCS) data indicates ten soil types within the study area (Table 1). One is considered to be hydric.

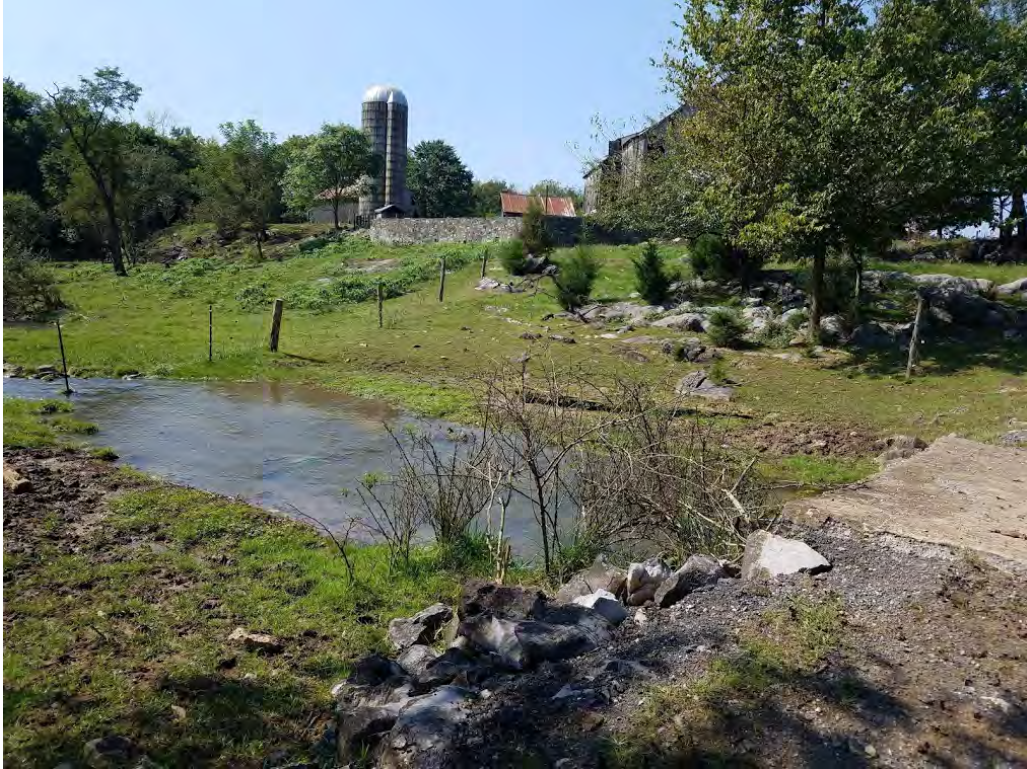
Photo 1: WW1 (Unnamed Tributary to Conococheague Creek) facing southwest at culvert crossing.

WW1 (Unnamed Tributary to Conococheague Creek) is classified as a perennial stream with a cobble/gravel substrate (R2UB1). The stream enters the study area from the north and flows south before continuing beyond the study area. The channel meanders through two forest stands and an open farm field, currently being utilized for grazing horse and cattle. The livestock have full access to the stream. The stream varies in width, averaging approximately 10 feet. The banks are wider at locations frequently used for cattle crossing. These areas have also accumulated sediment on top of the cobble/gravel substrate. WW1 is designated as a Use IV-P stream. Representative photos are included in Appendix C.

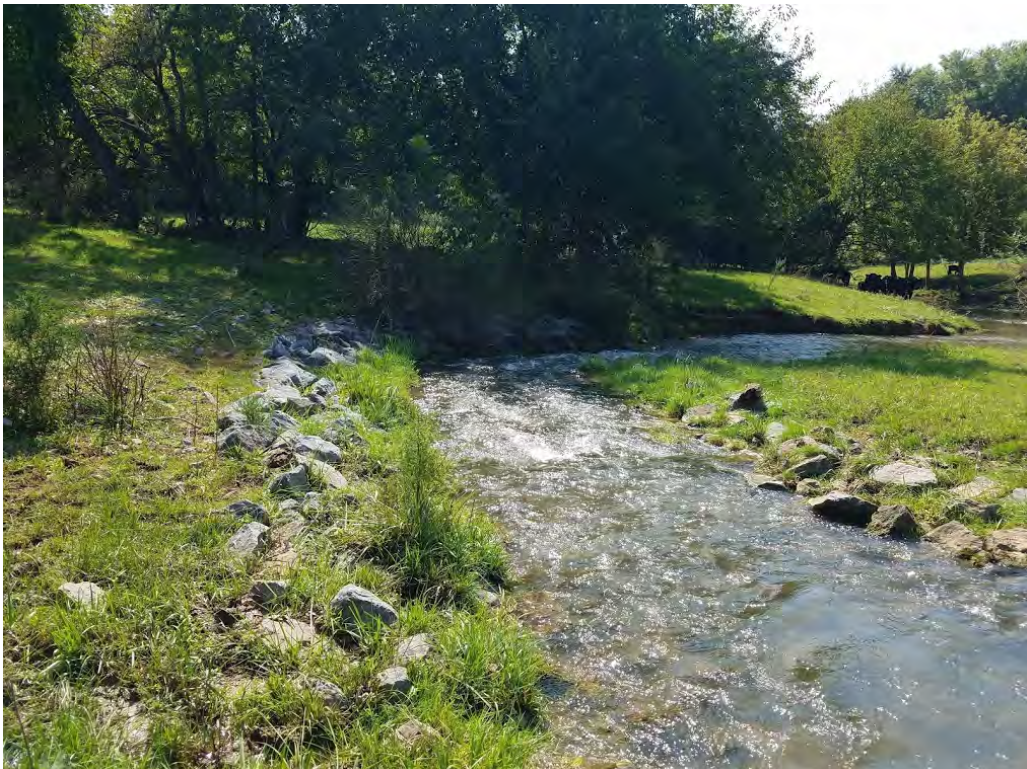
Photo 2: WW1 (Unnamed Tributary to Conococheague Creek) looking downstream at culvert crossing.

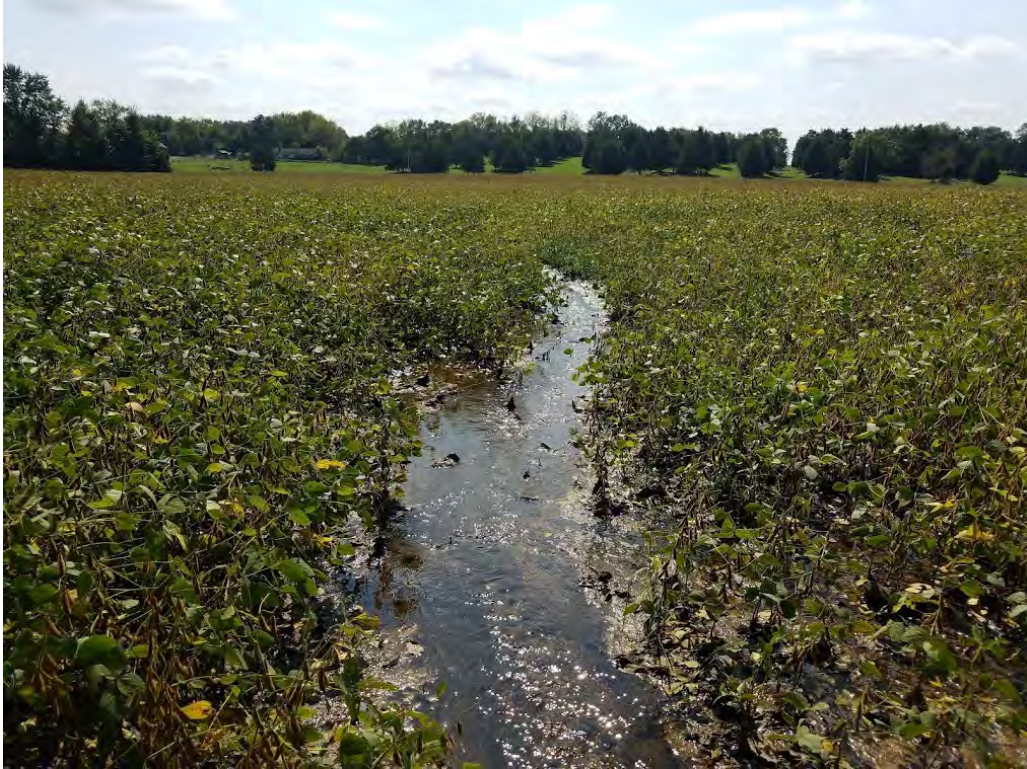
Photo 3: WW2 facing downstream from WET 1, within farm field.

WW2 is classified as a perennial stream with a mud substrate (R2UB3). It enters the study area from the northwest, in close proximity to Greencastle Pike. WW2 flows in a southeast direction through an active farm field and small residential property before its confluence with WW1. It should be noted that there were three inches of rainfall recorded the previous day (9/9/18), and a total of five inches over the course of the previous four days. At the time of investigation, the stream had exceeded its banks creating a large area of sheet flow through the soybean field. The stream channel limits were delineated based on visible stream characteristics such as defined bed and banks, sediment sorting, and scour in addition to recent aerial photography. The stream is approximately one foot wide through the farm field and three feet wide further downstream near the confluence with WW1. Water depths ranged from one to four inches. Representative photos are included in Appendix C.

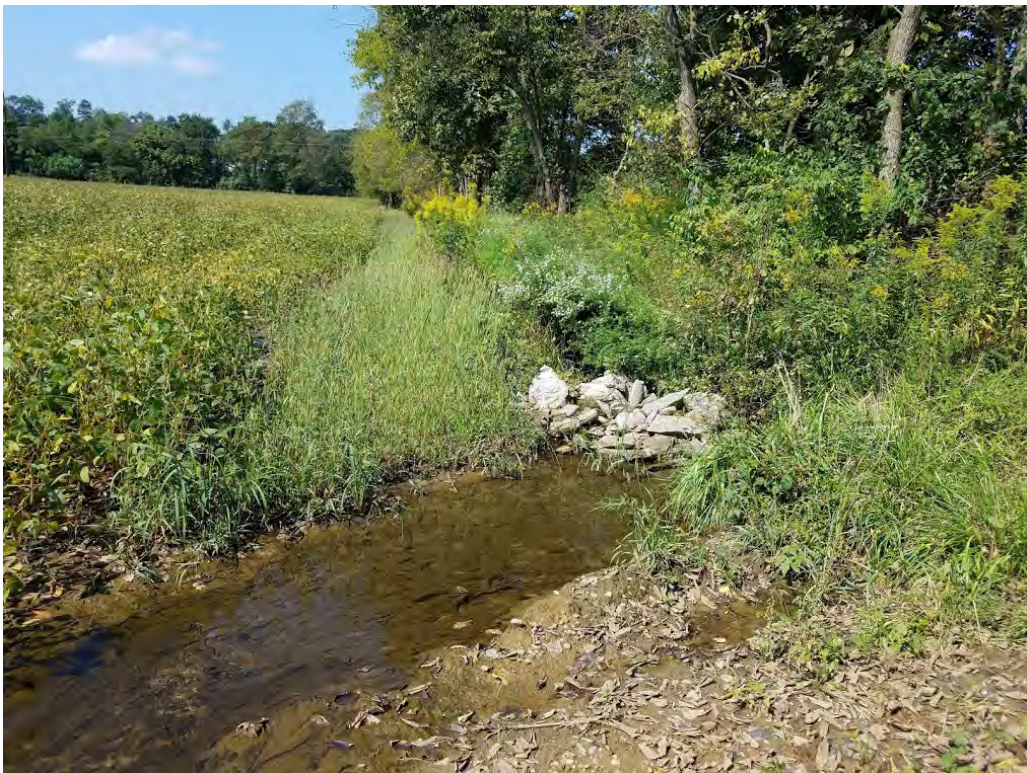
Photo 4: WW2 looking upstream (northwest); WET1 abutting stream to the west.

(PEM2f). The wetland abuts WW2 to the west, which appears to be the source of hydrology for this area. Data Plot #3 (DP-3) was used to characterize WET1. Hydrology indicators were Surface Water (A1), Saturation (A3), Algal Mat or Crust (B4), Recent Iron Reduction in Tilled Soils (C6), Drainage Patterns (B10), Saturation Visible on Aerial Imagery (C9), and Stunted or Stressed Plants (D1). Since the field is actively used for crops, the most abundant plant present was soybean (*Glycine*, sp.), which does not have a wetland indicator status. Hydric soil indicators observed were Dark Surface (S7) and Iron-Manganese Masses (F12). Representative photos are included in Appendix C.

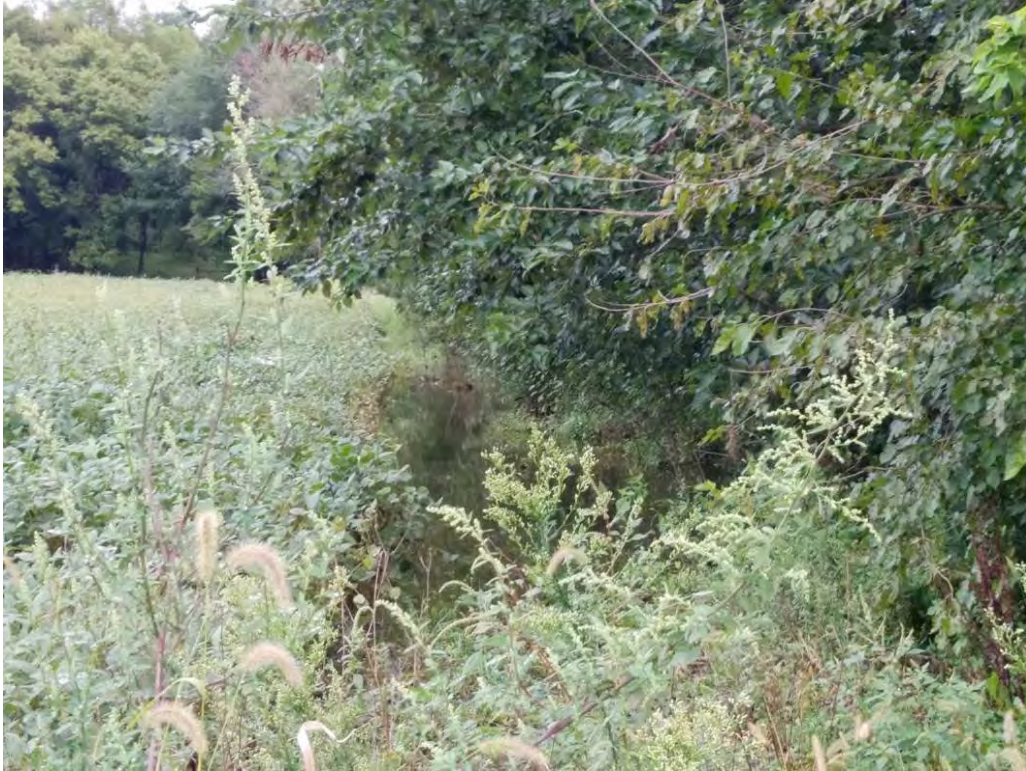
Photo 5: Standing at farm road facing WW2 at 90° channel bend.

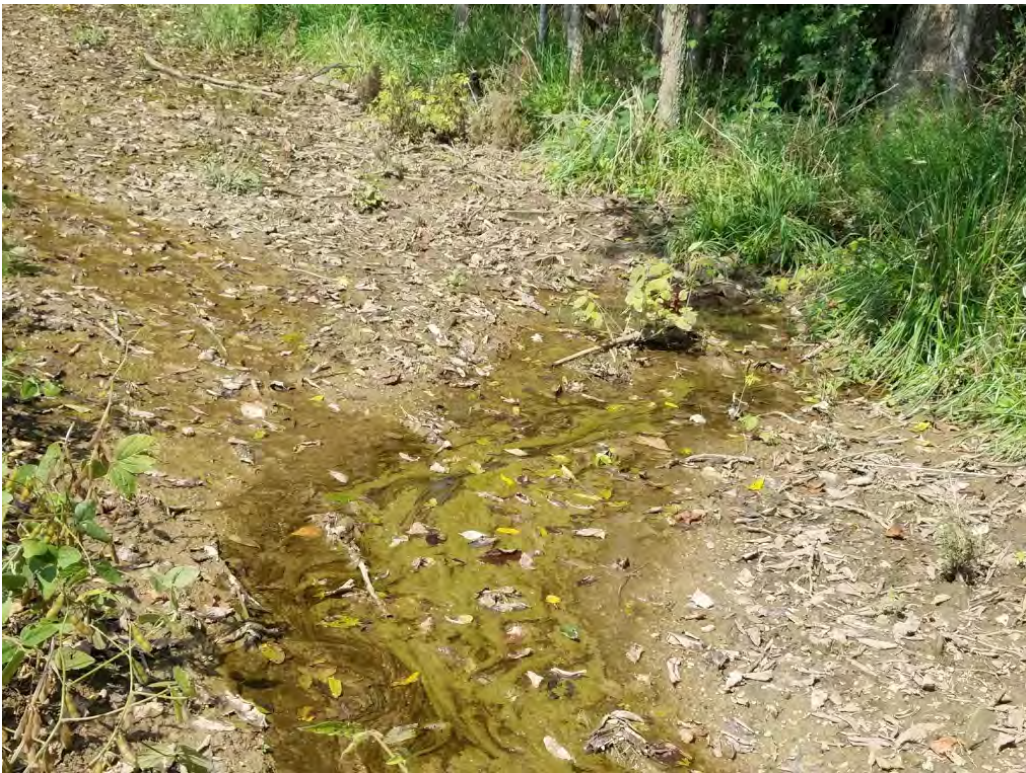
Photo 6: Upstream extent of WW2 at property boundary. WET1 (left) abuts WW2.

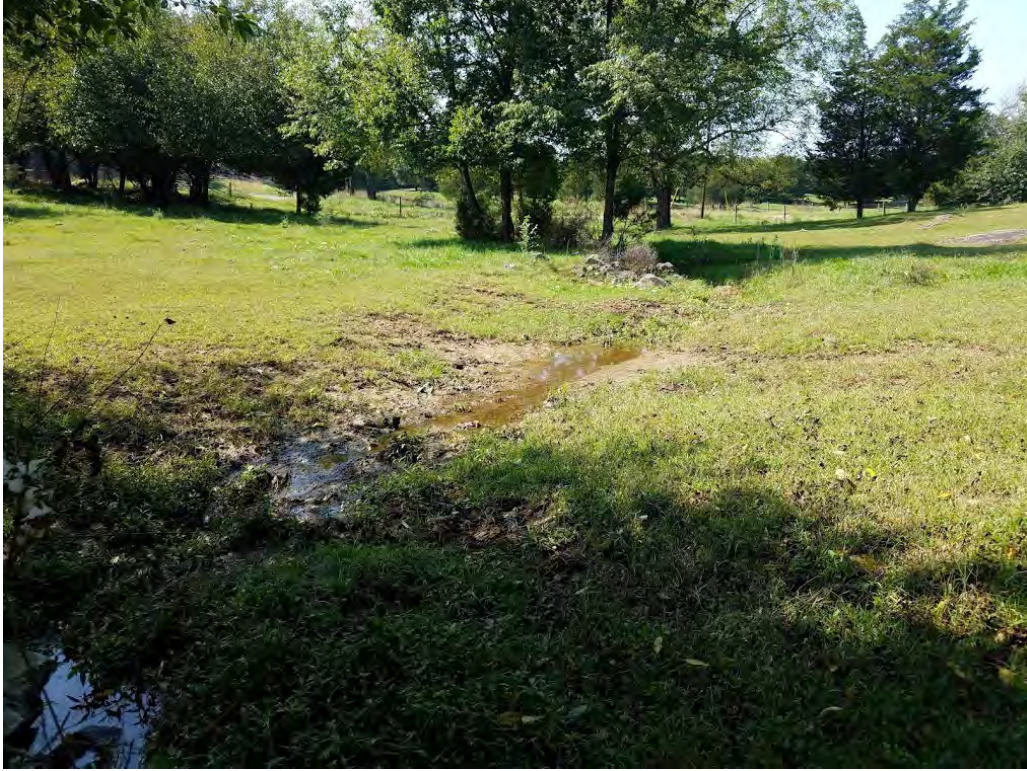
Photo 7: WW2 facing upstream at confluence with WW1.

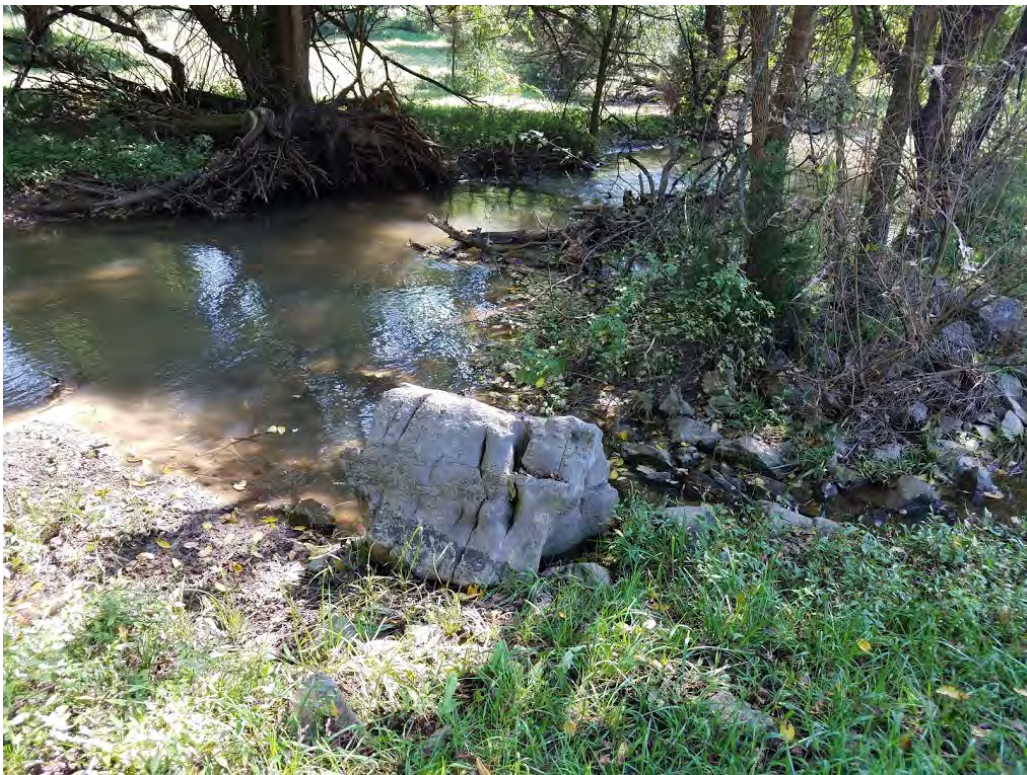
Photo 8: WW2 facing downstream at confluence with WW1.

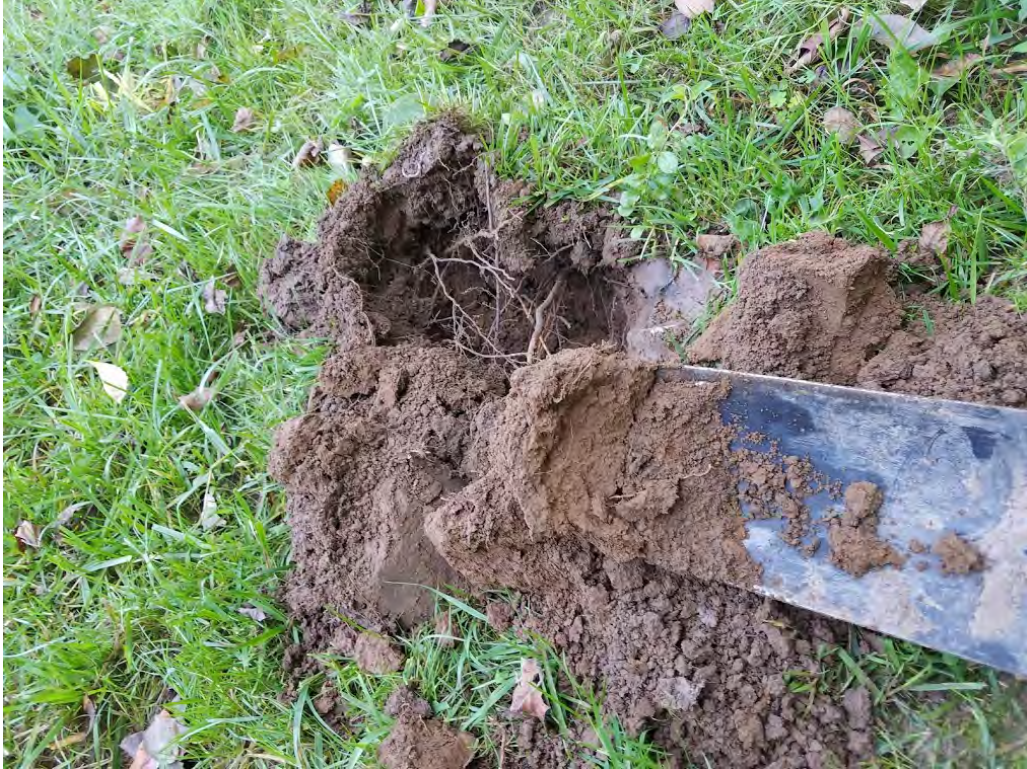
Photo 9: Portion of soil profile at DP-2 (10YR 5/3, no redox observed).

Depth (inches)	Matrix		Redox Features				Texture	Remarks
	Color (moist)	%	Color (moist)	%	Type ¹	Loc ²		
0-16	10YR 5/3	100						No redox observed
¹ Type: C=Concentration, D=Depletion, RM=Reduced Matrix, MS=Masked Sand Grains.							² Location: PL=Pore Lining, M=Matrix

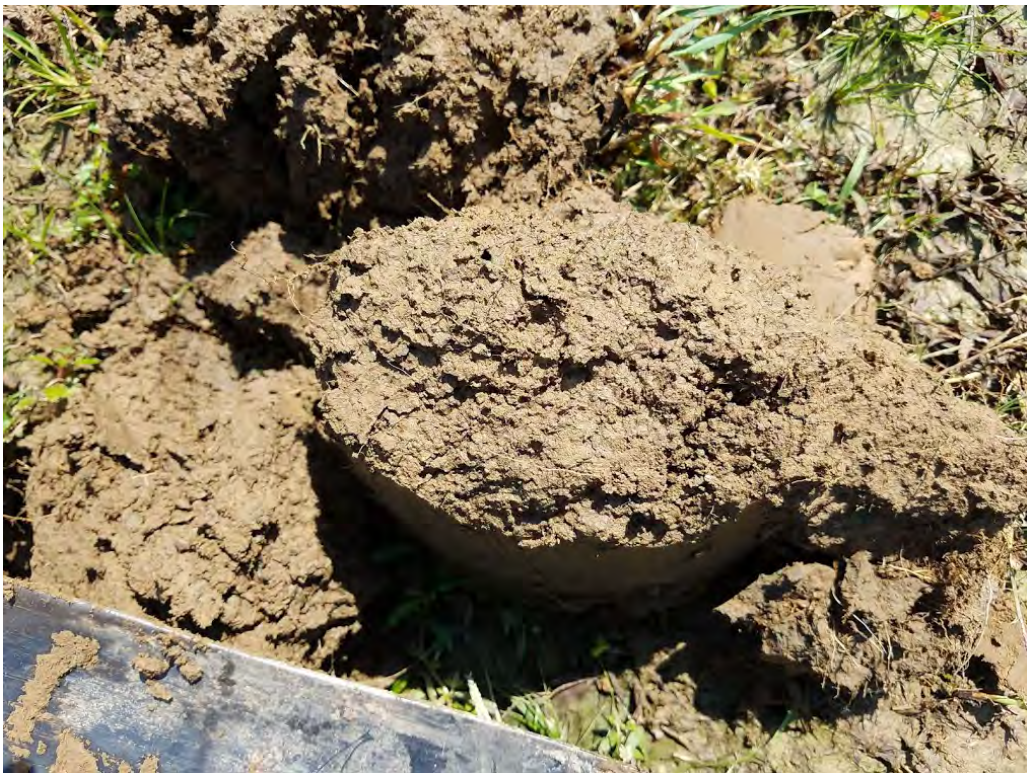
Photo 10: Portion of soil profile at DP-1 (10YR 5/3, no redox observed, wetter sample than DP-2).

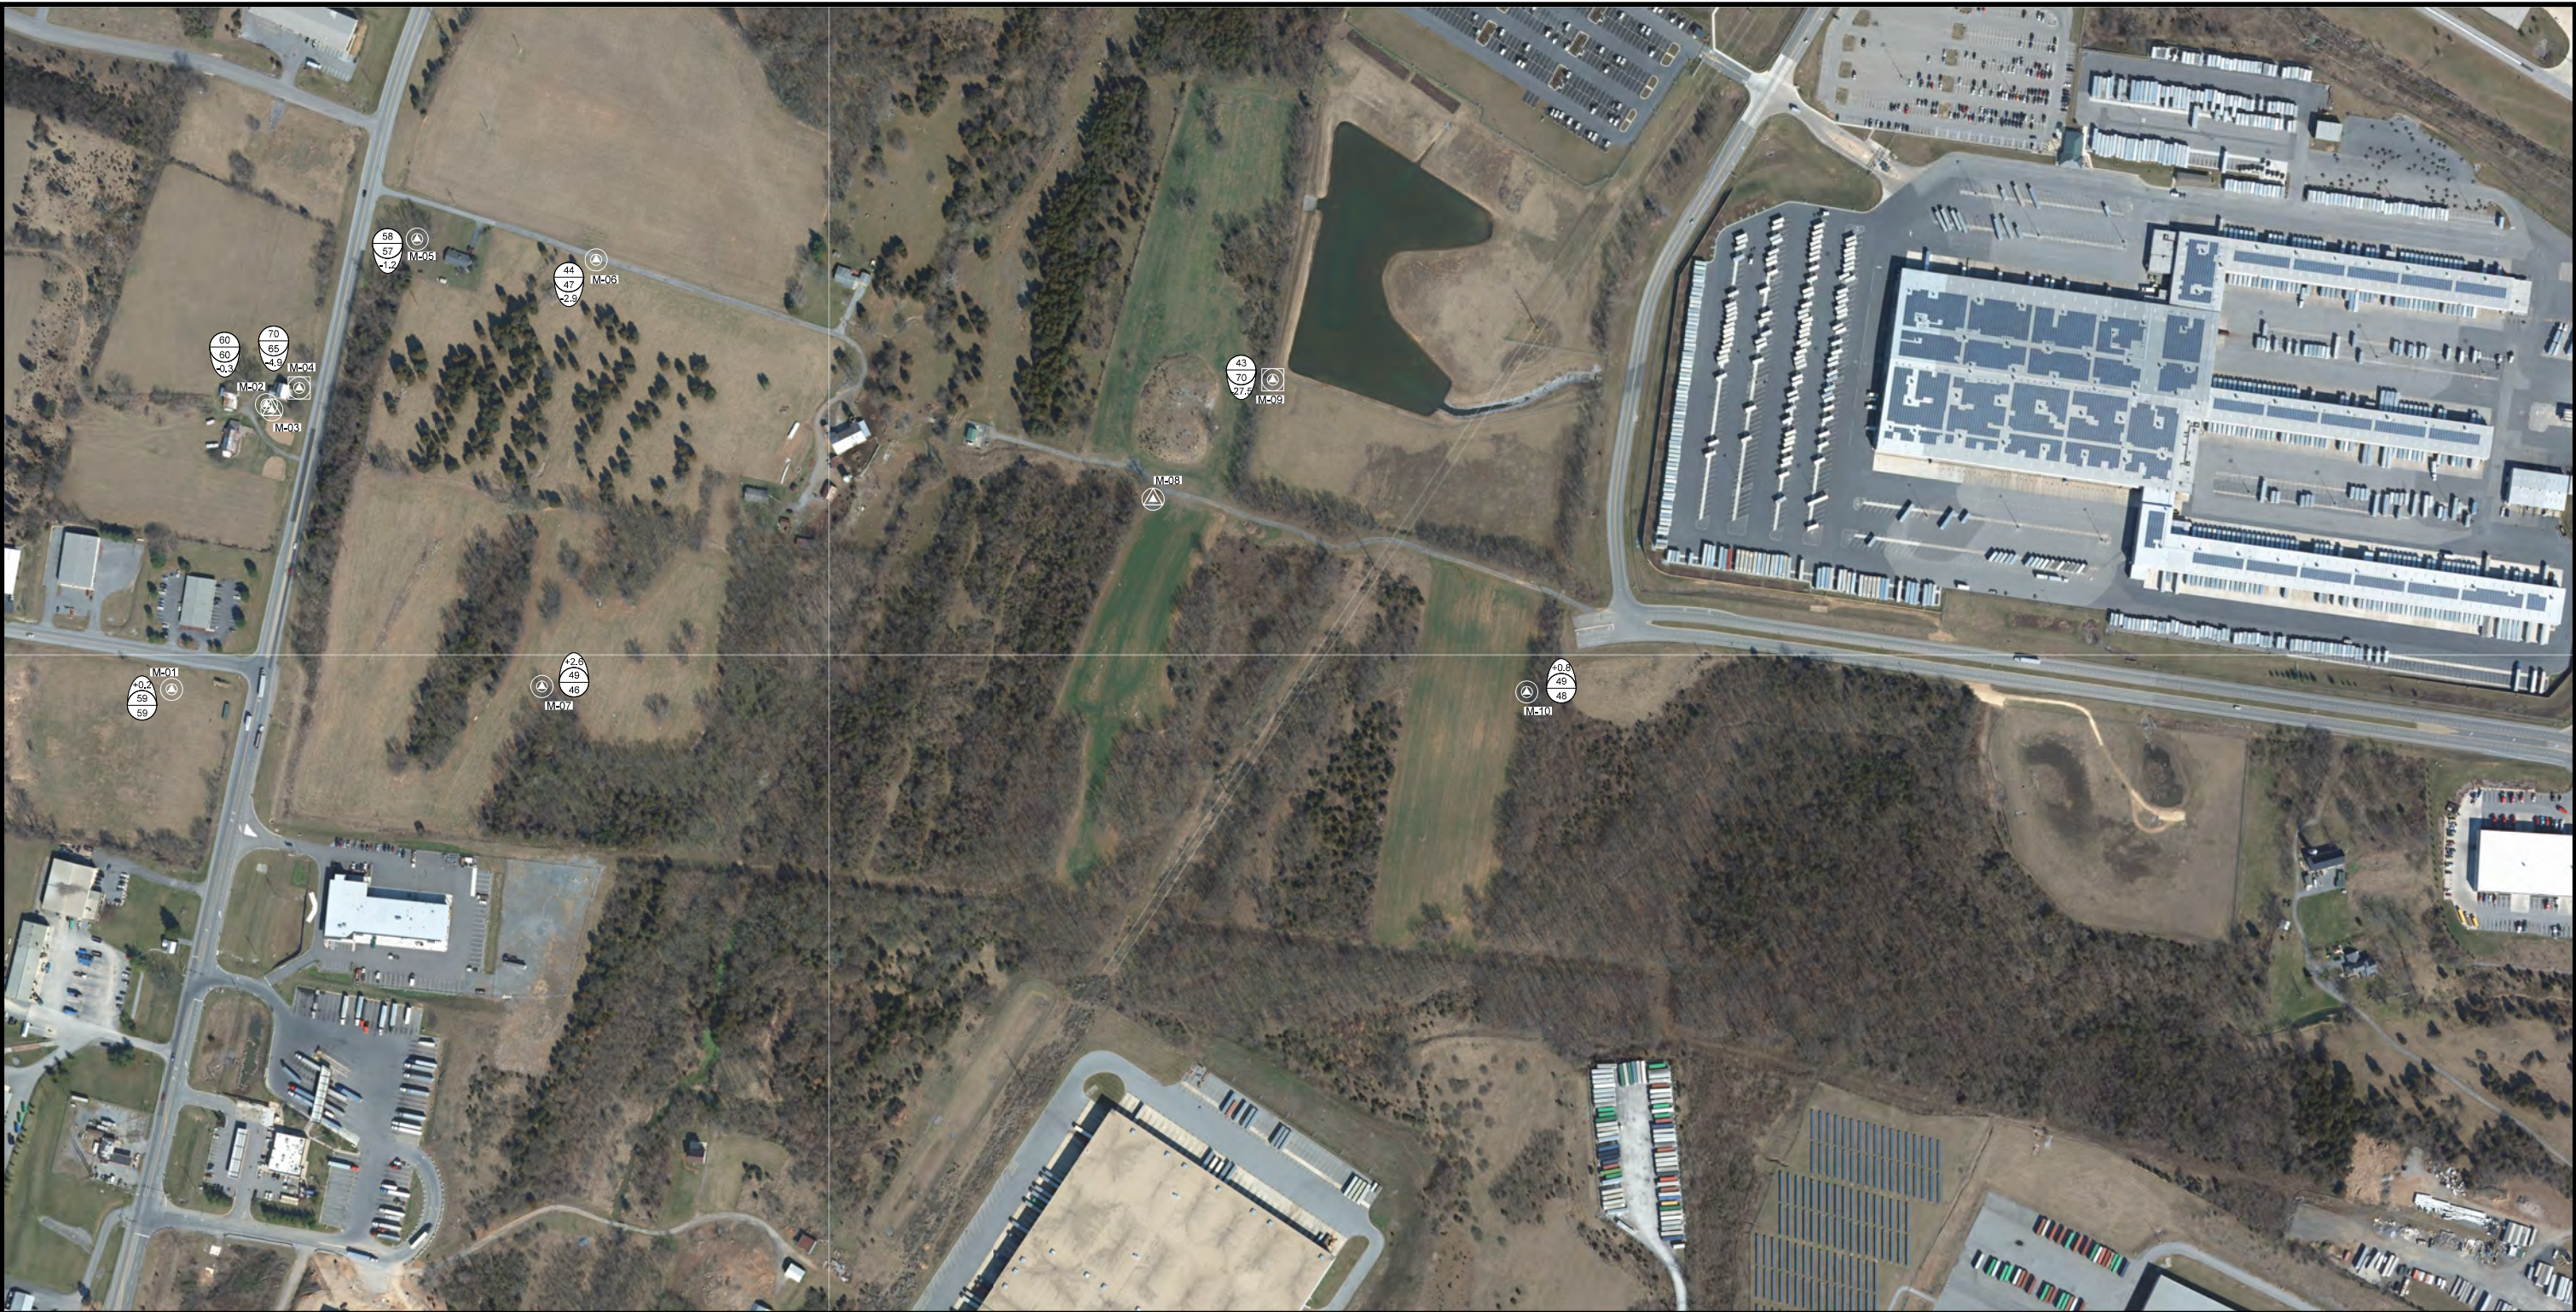
Figure 3

TNM Model Validation Map

A study of existing conditions was completed and then modeled in FHWA's TNM v2.5. Existing sound levels were measured and simultaneous traffic data was collected. The traffic data was input into the TNM validation models and the sound level results output from the model were compared to the measured sound levels. If the TNM output was within ± 3 dB(A) of the measured sound levels, then the TNM model was considered validated in accordance with FHWA and MDOT SHA. The proposed condition TNM model was evaluated using 2045 traffic data provided by Washington County. The proposed condition TNM model included the extension of Halfway Boulevard to the intersection of Greencastle Pike and Business Parkway. In addition to the eight measured receptors, fifty three receptors were added to the future prediction models in order to accurately determine the future sound level of those locations.
